REUSE STRATEGY AND ACTION PLAN

MARLBOROUGH SCHOOL SITE

1300 E. 75th, Kansas City, Missouri 64131

August 26, 2015

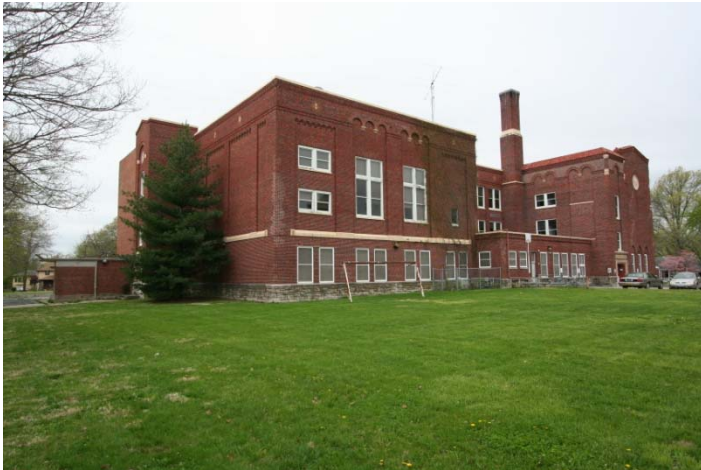
- Exterior Wall Construction: Tapestry brick with cream and polychrome terra cotta accents. Masonry is generally in good condition with limited areas requiring repointing, as noted.

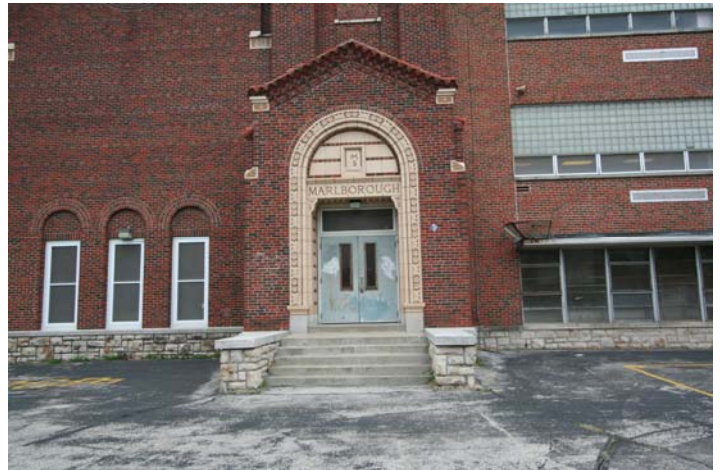
Main entrance

- Exterior Entrances: Paired non-historic aluminum doors with single vertical lights. Interior vestibule at the SW entrance retains historic wood elements, including paired doors, multi-light transom and sidelights. Entrances are generally in poor condition.

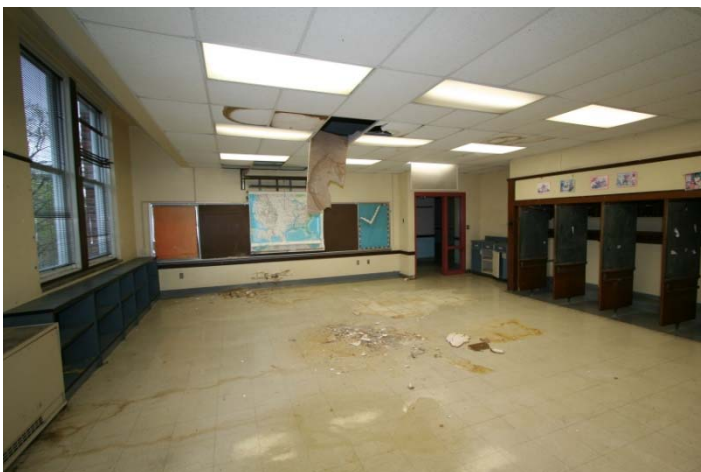
Classroom (1924)

- Classrooms: 1924 classrooms -- painted plaster walls with wood chair rail, dropped grid ceiling with lay-in acoustical tiles and vinyl composition tile or carpet on the floor. 1953 classrooms -- painted CMU walls, dropped ceiling grids (hang below concrete structure) and vinyl composition tile flooring. Materials and finishes are generally in fair condition.

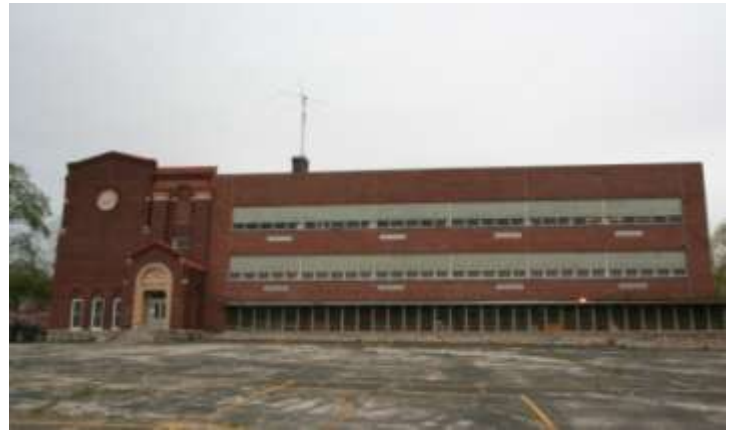
CONDITION RATING: **1/2

The building is structurally sound. The exterior envelop is in fair condition with some remaining usable life of the envelop components including the masonry and windows. The upper roof membrane is in poor condition causing multiple roof leaks and damage to the building interior. Interior finishes are in generally fair condition with typical wear from use, but a number of areas are in poor condition due to roof leaks. The mechanical and electrical systems appear to be sufficient and in good condition for immediate building use. The exterior site requires repairs of damaged areas, including parking and playground areas.
