Robeson

8201 Holmes Avenue

PHYSICAL BUILDING ASSESSMENT

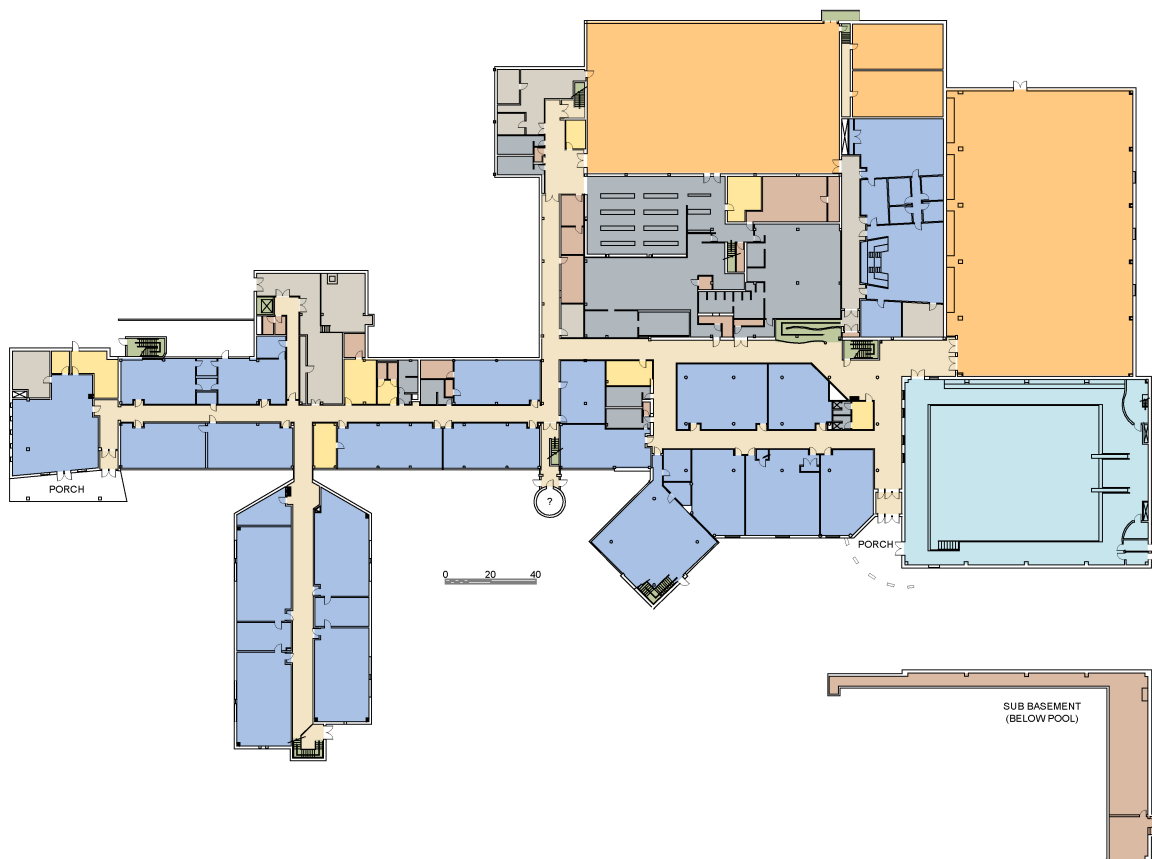
CLASSROOMS	AUDITORIUM
ADMINISTRATION	BUILDING SERVICES
MEDIA	CIRCULATION HORIZ.
CAFETERIA	CIRCULATION VERT.
GYMNASIUM	RESTROOMS
NATATORIUM	STORAGE

- Building size could be a barrier for redevelopment
- Typical classroom size is ± 850 SF. This size of classroom converts well into a single bedroom apartment or combines well into two bedroom apartments
- Large operable windows allow natural light and ventilation
- Parking is sufficient with easy access
- Large gymnasiums and auditorium in good condition
- Extensive areas of vandalism and graffiti on exterior and interior
- Building could be divided into multiple uses, for example it could be divided vertically into multiple areas or horizontally providing separation between lower floors and upper floors

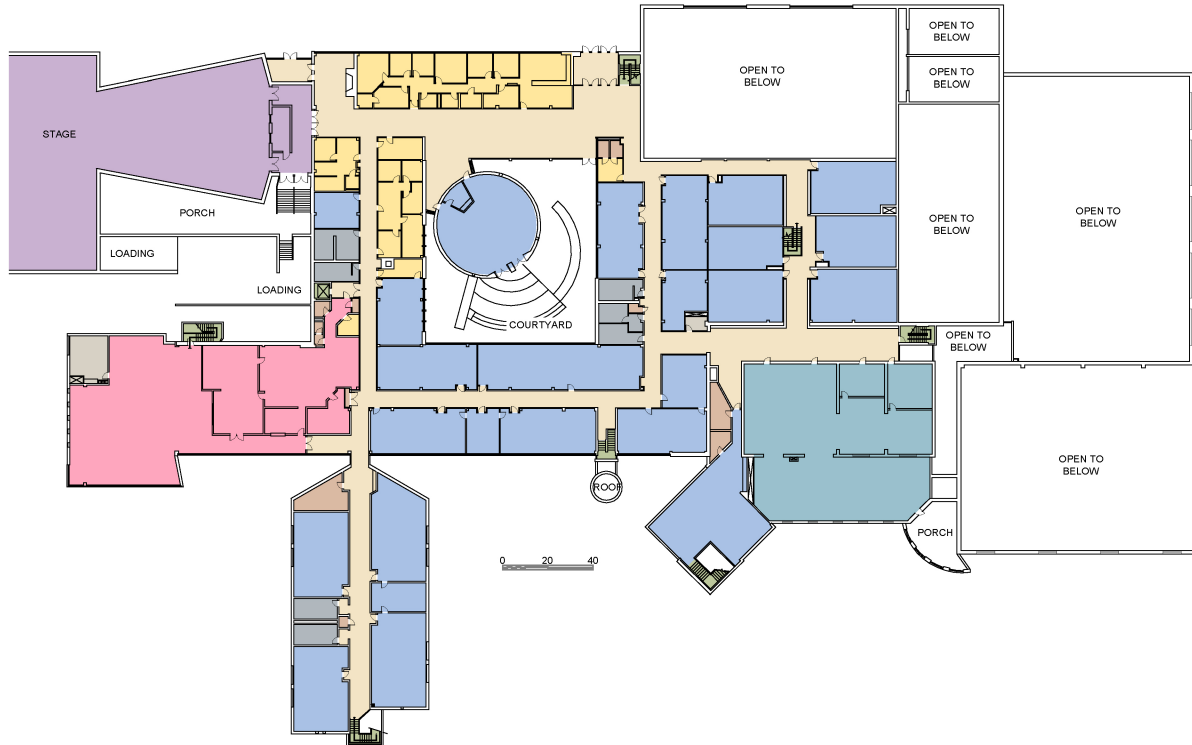
- Building size could be a barrier for redevelopment
- Typical classroom size is ± 850 SF. This size of classroom converts well into a single bedroom apartment or combines well into two bedroom apartments
- Large operable windows allow natural light and ventilation
- Parking is sufficient with easy access
- Large gymnasiums and auditorium in good condition
- Extensive areas of vandalism and graffiti on exterior and interior
- Building could be divided into multiple uses, for example it could be divided vertically into multiple areas or horizontally providing separation between lower floors and upper floors
